# TRANSACTIONS

VOL. LXXXVII

### HIGHWAY RESEARCH IN ILLINOIS\*

By CLIFFORD OLDER,† M. AM. SOC. C. E.

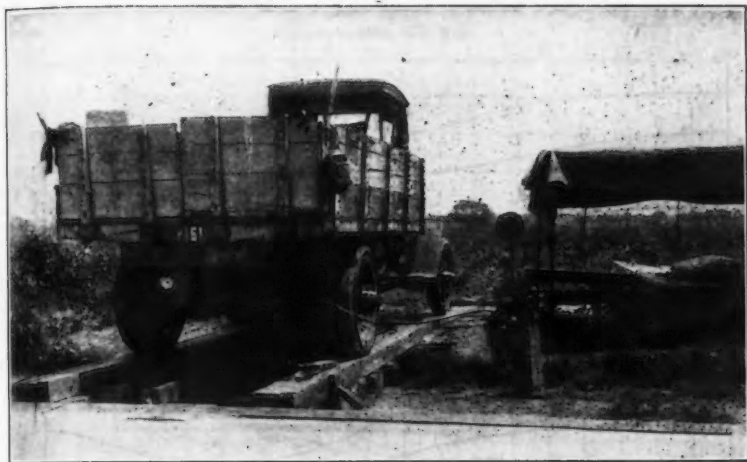
FIG. 2.—RUNWAY AND AUXILIARY TRUCK FOR APPLYING EQUIVALENT STATIC LOAD AT POINT OF IMPACT.

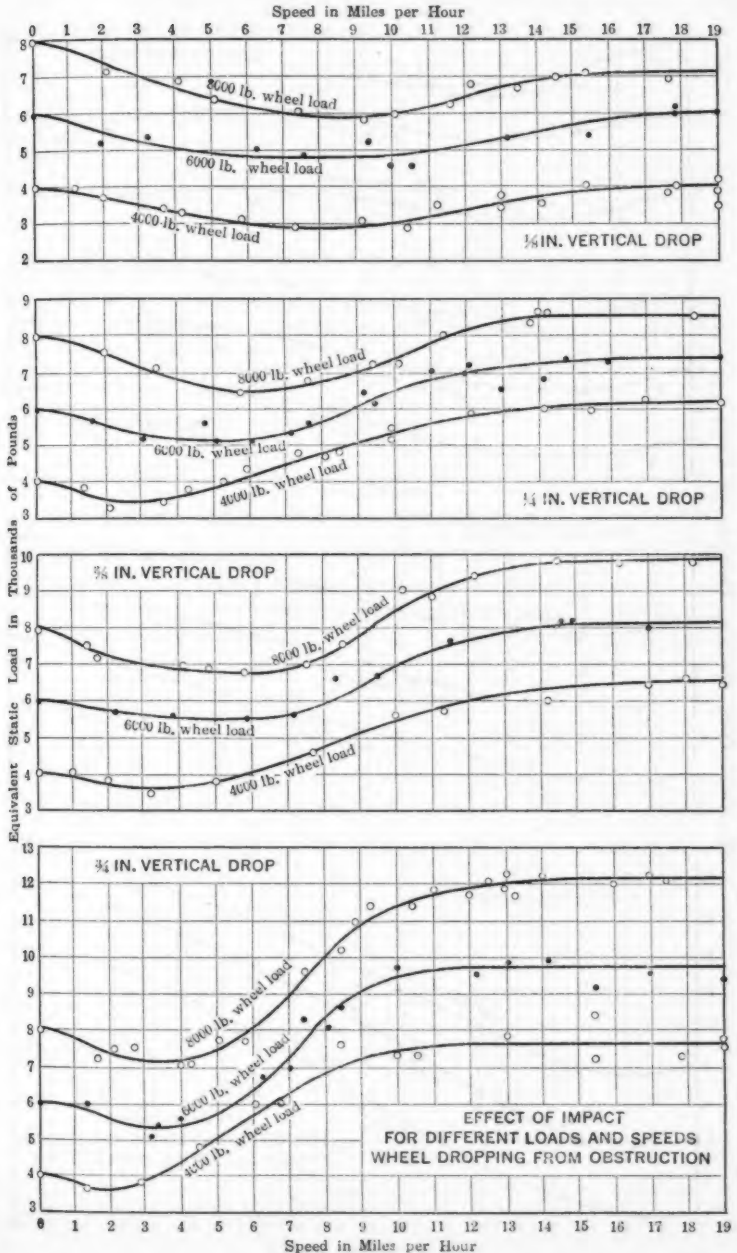
FIG. 4.

*Results of Impact Tests.*—Fig. 4 shows the results obtained for wheel loads of 4 000 lb., 6 000 lb., and 8 000 lb., for drops of  $\frac{1}{8}$  in.,  $\frac{1}{4}$  in.,  $\frac{3}{8}$  in., and  $\frac{1}{2}$  in., and for truck speeds varying from about 1 mile per hour to about 20 miles per hour. The unsprung weight was constant. Fig. 5 shows the results obtained under similar conditions, except that the truck moved in the opposite direction so as to mount the obstruction. The increase in wheel loads was effected by placing weights in the body of the truck and, therefore, above the springs.

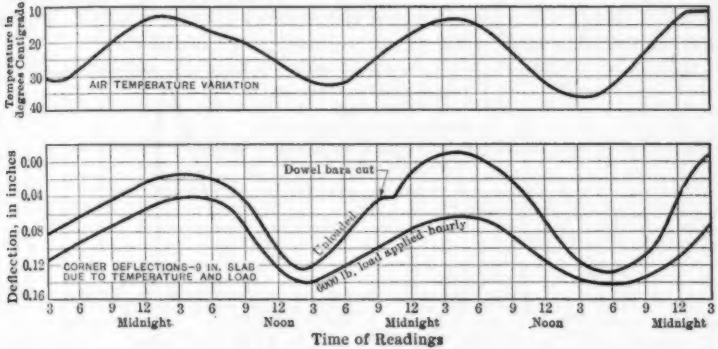
FIG. 6.

illustrates this for the corner of a 9-in. pavement slab during a 60-hour period, and shows also the deflection of the corner under a load of 6 000 lb. applied at hourly intervals throughout the period. Fig. 7 plotted from a number of simultaneous observations illustrates the warping effect of daily changes

A similar effectiveness of dowels in reducing deflections caused both by temperature and by loads, shown by comparing Fig. 9 (c) and Fig. 9 (d), is also indicated clearly by the observations of Fig. 6, during which the dowel bars in the corner were cut. On the night following the cutting of the dowels, when the range in temperature was the same as during the previous day, the warping increased and the deflection under load more than doubled.

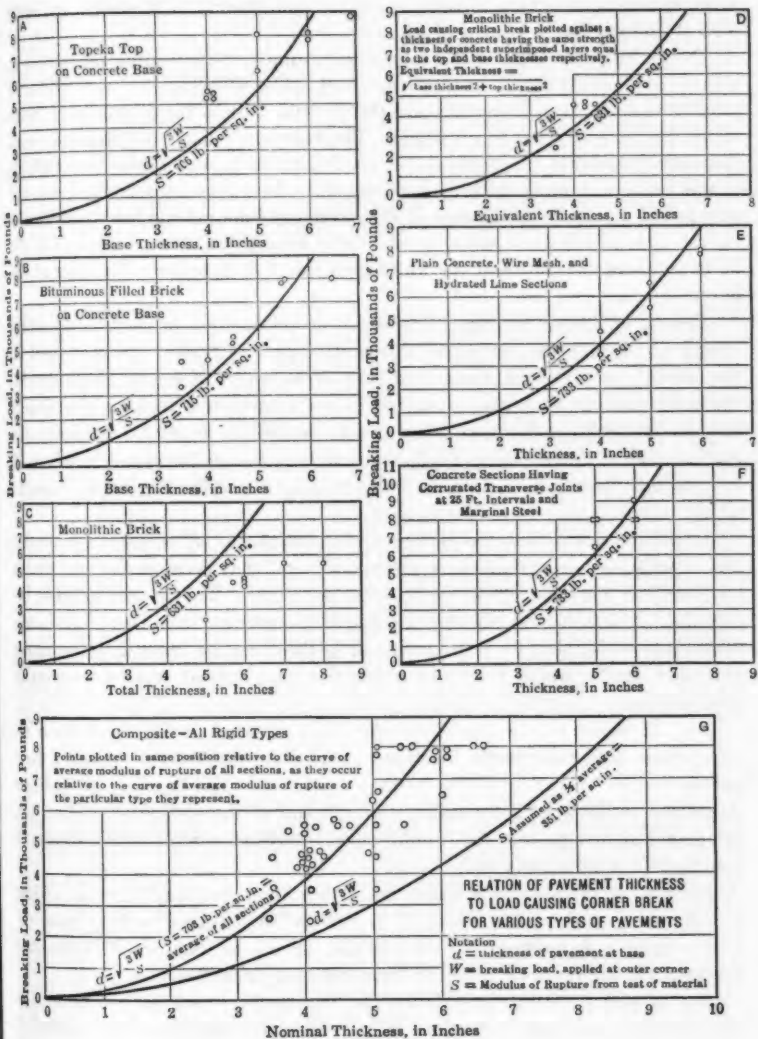
FIG. 17.

*Concrete Sections.*—In Fig. 17 (e), the plotted points show the loads causing critical corner failure in all plain concrete sections, and in sections considered as equivalent to plain concrete. These points include two sections of plain concrete, to which had been added 10% of hydrated lime; and two sections containing 42-lb. wire mesh placed at about the neutral axis. Considering the quantity and location of the steel in these sections, it would afford little, if any, relief of tensile stresses in the concrete.

In Fig. 17 (f) are shown the loads causing critical corner failure in all concrete sections which were provided with transverse joints spaced at 25-ft. intervals. These joints were formed by ordinary corrugated metal sheets placed on edge, the corrugations running horizontally. The concrete was poured against these metal sheets, no provision being made for expansion. This construction merely resulted in a transverse crack having a corrugated cross-section. The inclusion of these test sections was based on the assumption that possible intermediate transverse cracks would not be formed; that contraction would occur only at the joints; and that, because of the corrugations, more or less mutual support would be afforded by adjacent slabs, thus making corner failure less probable. All the plotted points in this diagram represent sections in which  $\frac{3}{4}$ -in. steel marginal bars were used. The position of the plotted points indicates that the presence of the transverse corrugated joints had little effect in increasing resistance to structural failure.

In Fig. 17 (*g*), the plotted points represent the loads causing critical corner failures in all sections of rigid type. These points were plotted in the same position relative to the curve determined by the formula,  $D = \sqrt{\frac{3W}{S}}$  (using for  $S$  the average modulus of rupture of all test specimens), as they appear in Fig. 17 (*a*) to (*e*). In this diagram, attention is called to the grouping of the plotted points about the curve representing the theoretical breaking load as determined by the formula given. It will be noted that the lower curve, in which 50% of the modulus of rupture was used, gives safe values for all cases causing critical failure.

group of sections having an asphaltic concrete top on a concrete base. Failure always started at a south side corner. Progressive failure after the initial corner break, however, was more rapid. These sections were provided with an integral curb having a depth equal to the combined thickness of the brick surfacing and the sand cushion. The thickness used in plotting Fig. 17 (b) does not take into account the presence of the curb.

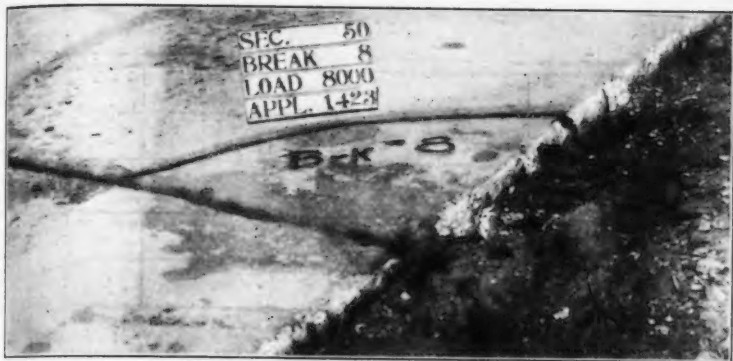
FIG. 18.—TYPICAL CORNER BREAK IN A CONCRETE SECTION.

The grouping of the points about the theoretical breaking load curve indicates also that fatigue effect was not a predominant cause of failure in this test. To have operated the trucks a sufficient number of times and with sufficiently small increases in load to bring out the fatigue effect, would have been an endless task. The increments of load were no doubt great enough in most cases to increase the fiber stress from that which would be safe, as far as fatigue is concerned, to a figure which would result in breakage under comparatively few repetitions of load. (See Figs. 18, 19, and 20.)

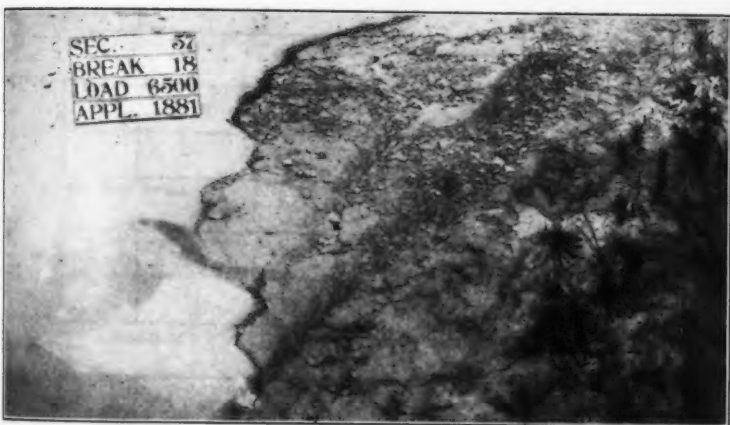
FIG. 19.—EARLY STAGES OF PROGRESSIVE DESTRUCTION FOLLOWING CORNER BREAK.
