## Arizona

## **Querino Canyon Bridge**

The Querino Canyon Bridge is listed on the National Register of Historic Places.

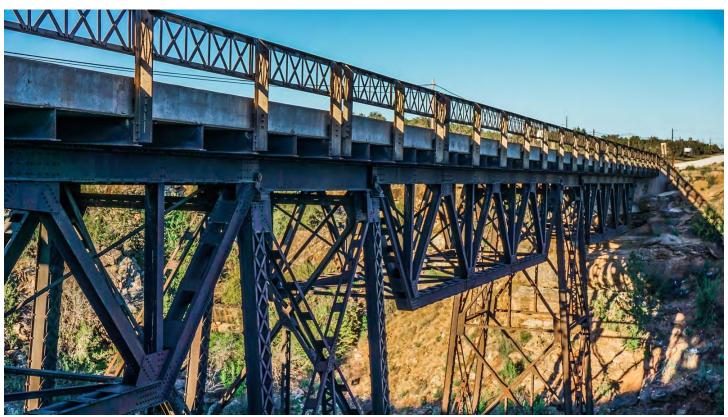
NPS Photo courtesy of Rhys Martin

The Querino Canyon Bridge is picturesquely situated over a rugged and beautiful canyon just outside Houck, Arizona. Designed by the Arizona Highway Department, the bridge is a representative example of early highway truss design. There are three concrete-decked steel Warren trusses with sub-verticals supported by steel piers. Each truss is about 77 feet long and 20 feet wide. Concrete abutments support the bridge from below and steel lattice guardrails typical of the period line the roadway. [This paragraph adapted from the National Park Service description to provide a more technically correct explanation.]
